# Instituto Panamericano de Ingeniería Naval XII COPINAVAL - Setiembre /Octubre 1991

## BULK CARRIERS - THE SAFETY ISSUES

J. C. ADAM, J. M. FERGUSON, D. W. ROBINSON  
LLOYD'S REGISTER OF SHIPPING, ENGLAND

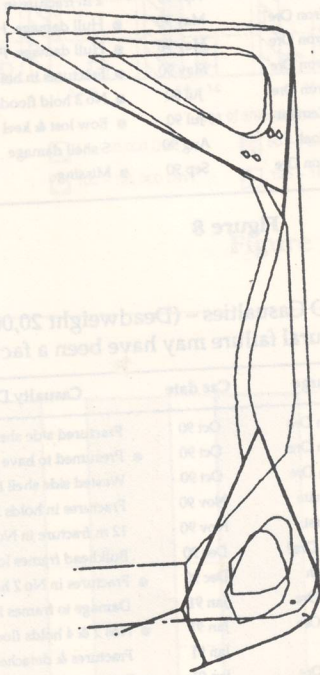
**Figure 12**

Loadings on the main frames and their brackets are complex and are generated by hydrostatic load and the rotation of the hopper and topside tanks. Cyclic loadings are induced from these load sources by the passage of waves and the motion of the ship in a seaway. See Figure 12.

**Frame/hopper deformation in Ore loading condition**
