Paper for  
Pan-American Institute of Naval Engineers (IPEN)  
Shaft Strut Cavitation Problems

by  
F. Sherman Cauldwell and A. Steven Toby  
Naval Sea Systems Command  
Washington, D.C. 20362

September 1983

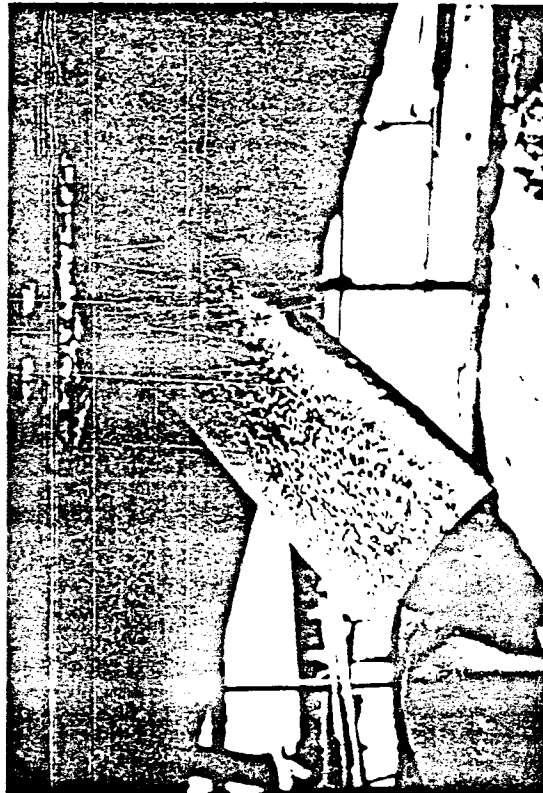
Figure 3  
Typical Strut Erosion

In recent years there has been a history of the struts having experienced deterioration damage. This is exhibited by the struts becoming pitted on their surfaces and by the development of notches in the strut trailing edges. This has been caused by cavitation erosion or corrosion, or both. In some cases, the cavitation generated at the struts has carried aft to cause deep pitting of the propeller blades near their hub.

When the cavitation bubbles collapse against the strut, they exert very large local pressures which not only remove the paint coating, but also develop pits in the metal. These areas of bare metal are then subject to electrolytic corrosion, which can be accelerated by lack of cathodic protection in this region. If the stream of cavitation is sufficiently strong, the bubbles can be carried aft so as to impinge on the propeller, where their collapse can severely pit the propeller blades.

More recently, NAVSEA's attention has been called to some of the still unrepaired ships. Two of them (Ships C and D) have required extensive propeller repairs or replacements. On inspecting Ship C and photographs of Ship D in 1981, it was discovered that their struts were in a deplorable condition (Figure 3), being badly eroded and far from the designed section shape. Instructions were issued to repair the struts by welding and grinding. It is possible that, as in the case of Ship B, repair of the struts will stop the deterioration of the propellers.

In any case, care should be taken to properly shape the struts. Cusped leading edges should not be permitted. Shoulders, such as frequently occur in the strut-to-barrel fillet should be avoided. In other words, care should be taken to provide an elliptical shape in the nose area. Care needs also to be taken to assure fairness of the strut section.

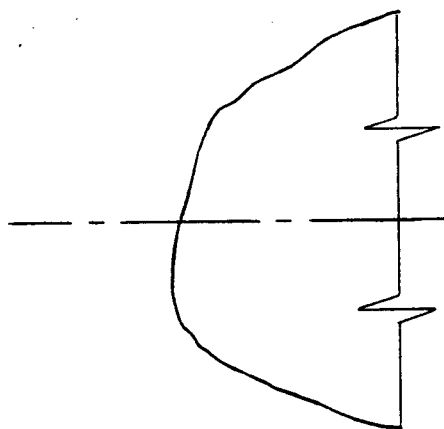
4a. In way of strut-to-shaft barrel fillet

Thus, generation of cavitation can be due to improper shaping or fairness of the struts or due to their misalignment with the flow past the struts. In fabricating the struts, lack of attention to detail in their shape can result in the leading edge being cusped (spined) rather than rounded as is called for by the elliptical nose, so that cavitation is generated when an angle of attack occurs. Alternatively, the nose may be blunted, so that shoulders occur shortly aft of the leading edge; this results in a low pressure area which triggers cavitation.
