# Instituto Panamericano de Ingeniería Naval XII COPINAVAL - Setiembre /Octubre 1991

## BULK CARRIERS - THE SAFETY ISSUES

J. C. ADAM, J. M. FERGUSON, D. W. ROBINSON  
LLOYD'S REGISTER OF SHIPPING, ENGLAND

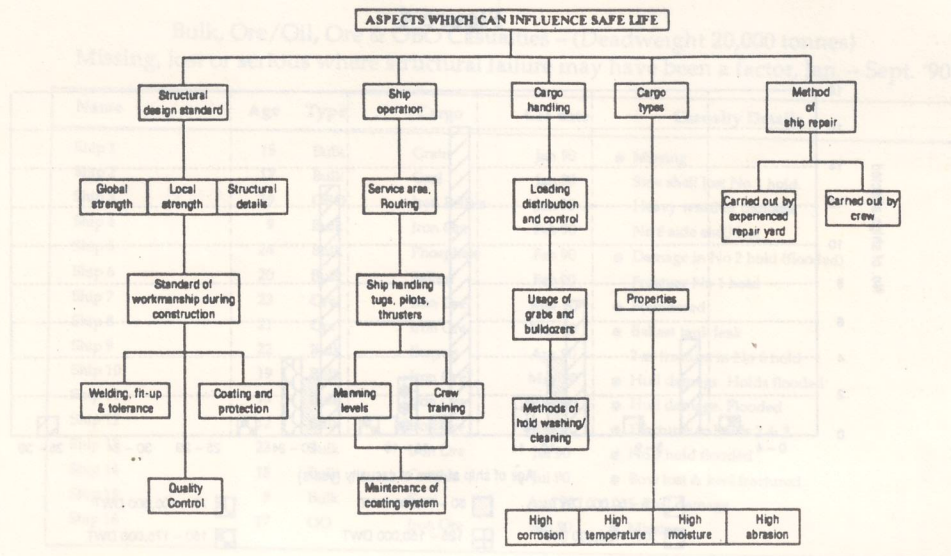
Aspects which can influence the life of bulk carriers are shown in Figure 2 and include structural design, ship operation, cargo handling aspects, types of cargo and maintenance and repair policies. These topics are generally addressed in this presentation although not necessarily under these specific headings.

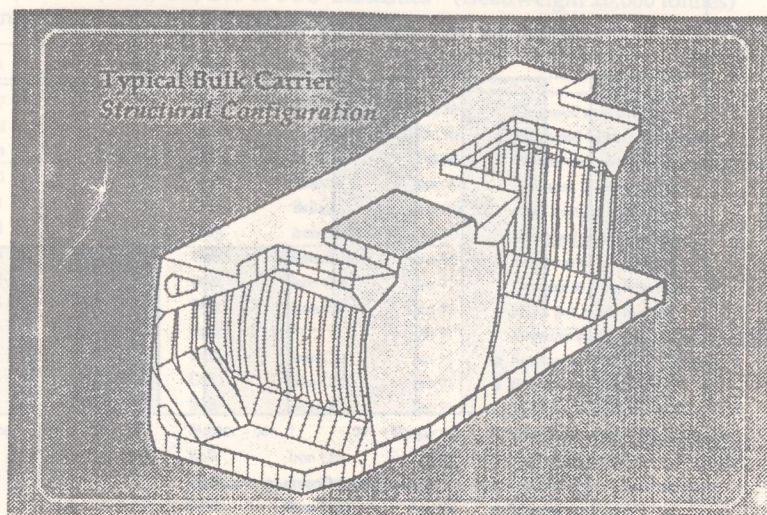
Figure 3

The most widely recognised structural concept identified with a bulk carrier is a single deck ship with a double bottom, hopper tanks, single transversely framed side shell, topside tanks and deck hatchways. This concept, as described, dates back to the early nineteen sixties when deadweights of up to about 20,000 tons were introduced. During the period until the early nineteen seventies this design configuration was extended to ships of about 170,000 tons deadweight. During the mid sixties the utility of the ship type was further developed when the O.B.O. (Ore, bulk, Oil) ship was conceived. This development in operational capabilities came after considerable investigation which concluded that this ship type could carry liquid oil cargoes without destroying basic simple structural concept. An outline structure arrangement for the cargo area of a bulk carrier is shown as Figure 3.

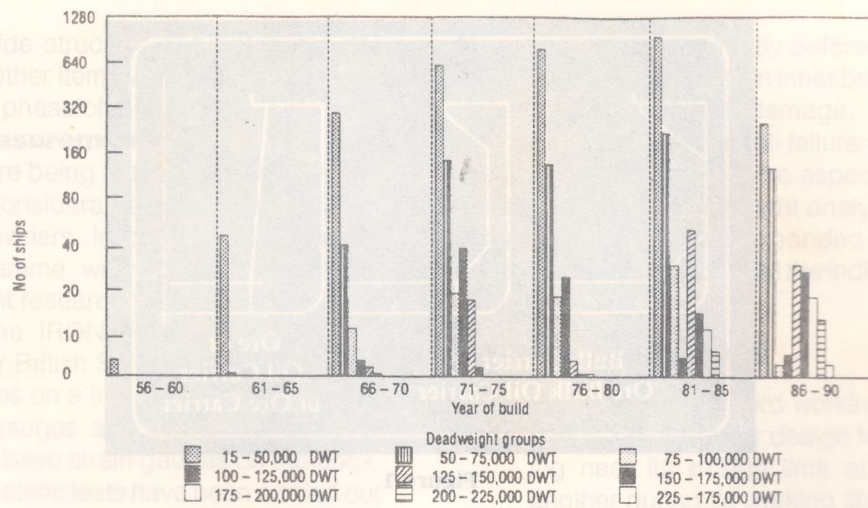
Figure 4

The age structure of the bulk carrier fleet is shown in Figure 4. From this figure it will be noted that the fleet is a reasonably balanced fleet in terms of size, up to about 100,000 t dwt, for ships built between the early seventies and mid eighties. During the early eighties there appears to be an upswing in newbuildings for ships above 125,000 t dwt. By far the majority of the ships which form the bulk carrier fleet are the handy sized ships ranging in age up to over 30 years.

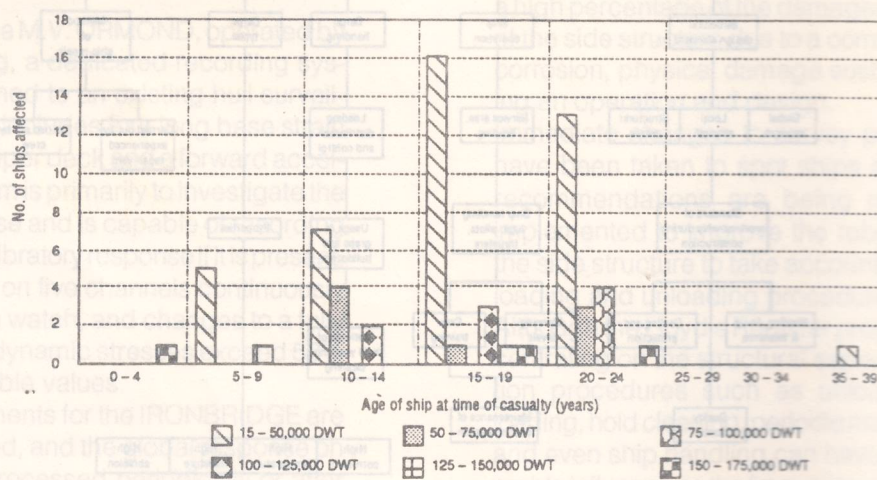
Figure 5

Figures 5, 6 and 7 illustrate the loss of dry bulk carrying ships, where such losses can be attributed to structural failure, from the end of 1979 to date, i.e. ships which have had reported hull leakages or have simply gone missing. The ship types include single hull and double hull bulk carriers as well as ships with an ore carrier structural configuration. Over this time period the average rate per year is about 6 ships with the highest level being 12 ships during the year 1990.

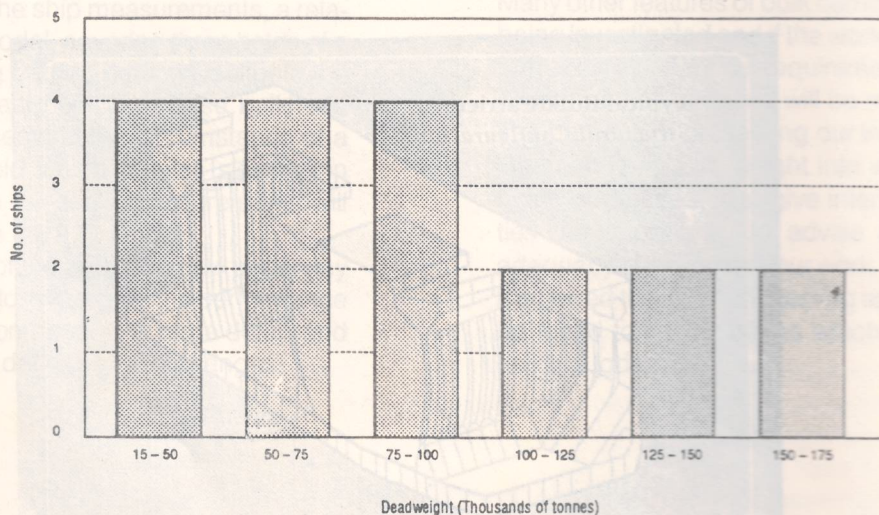
Figure 6

**Bulk Carrier Total Losses Where Structural Failure May Have Been A Factor  
(1980 - 1991) 15,000 T. DWT Upwards**
